**THE CITY OF PLATTEVILLE, WISCONSIN
COMMON COUNCIL AGENDA**

- I. **CALL TO ORDER**
- II. **ROLL CALL**
- III. **WORK SESSION** – 250 East Main Street
- IV. **ADJOURNMENT**

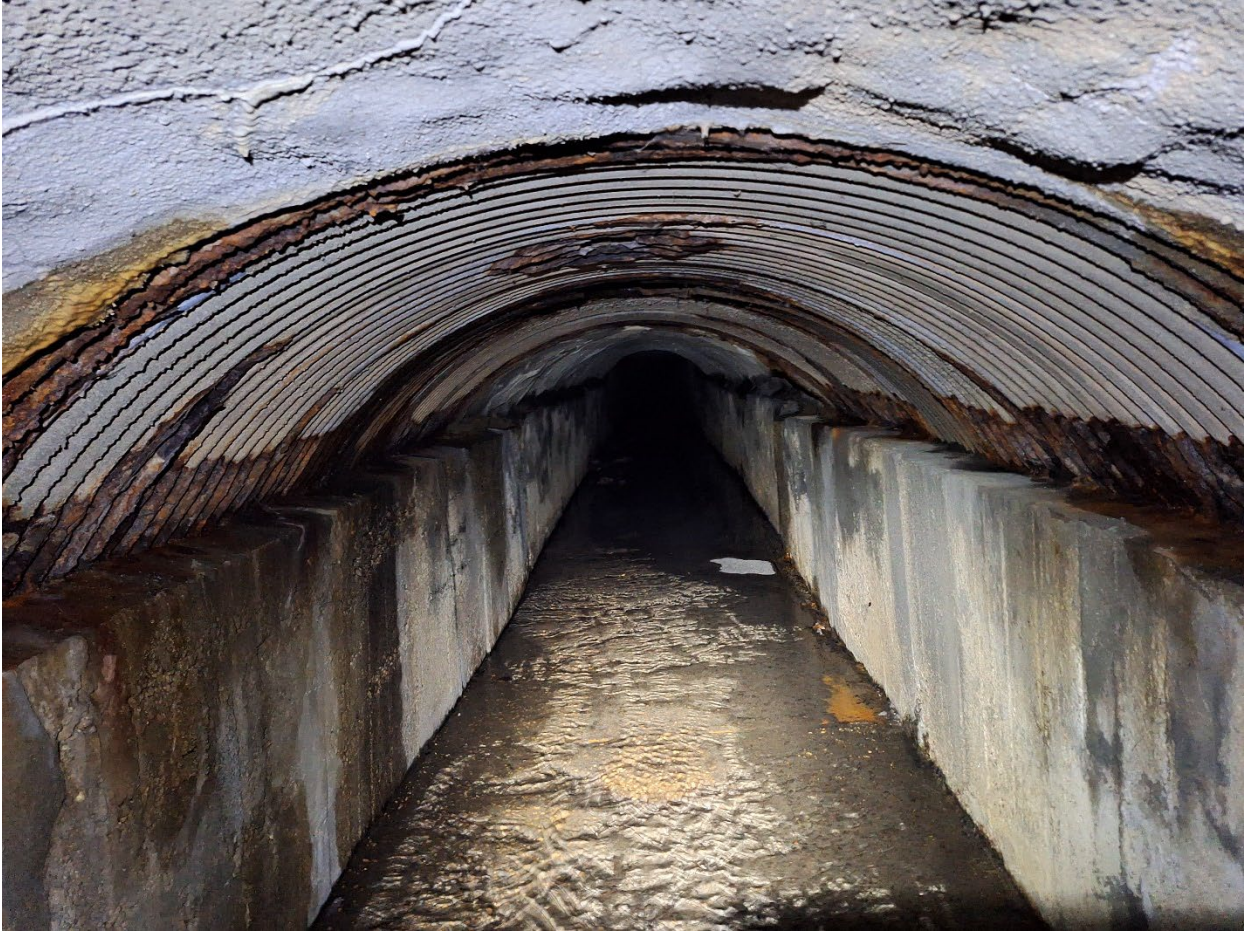
Attached to the February 9, 2024 report is a photo of the channel as it transitions from the open area under 250 E. Main Street to a channel. In that photo, it appears that the arch above the box channel was a metal pipe that was sprayed with a concrete coating. This will extend the life of the metal pipe, but if it was rusted before the concrete spray, it will not be as effective. Approximately where the channel exits the foundation of the building/under the sidewalk, there is a transition back from sprayed concrete to plain metal pipe. It is plain to see that the metal pipe is severely rusted. In the Staff note, this is the portion that Staff is deeply concerned about if we delay the project or not replace storm sewer.

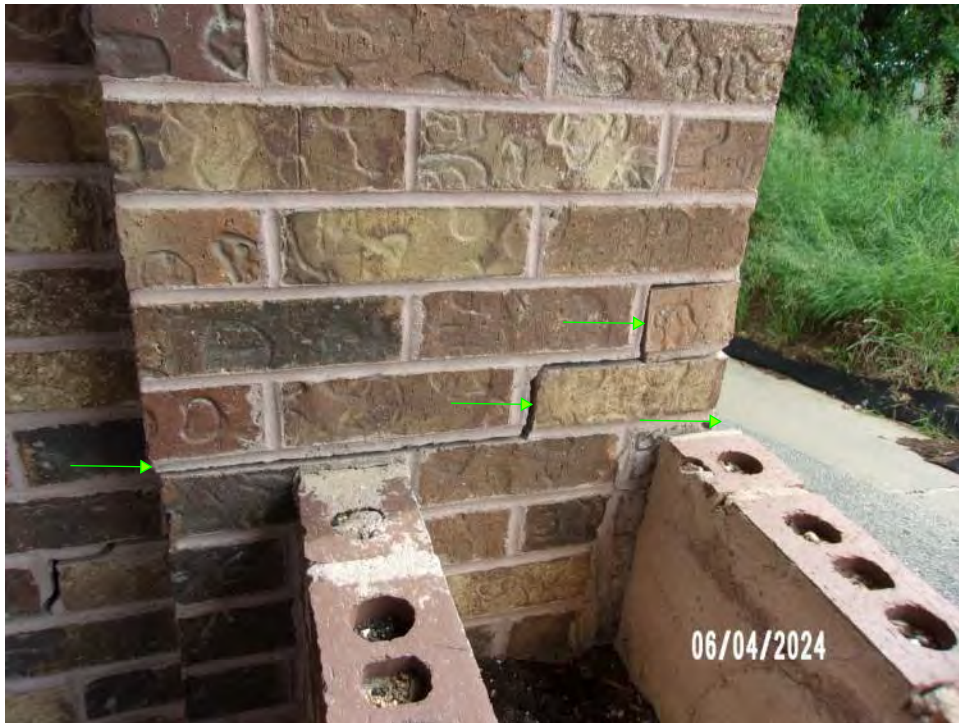
Photo 8 - Crack in south brick wall

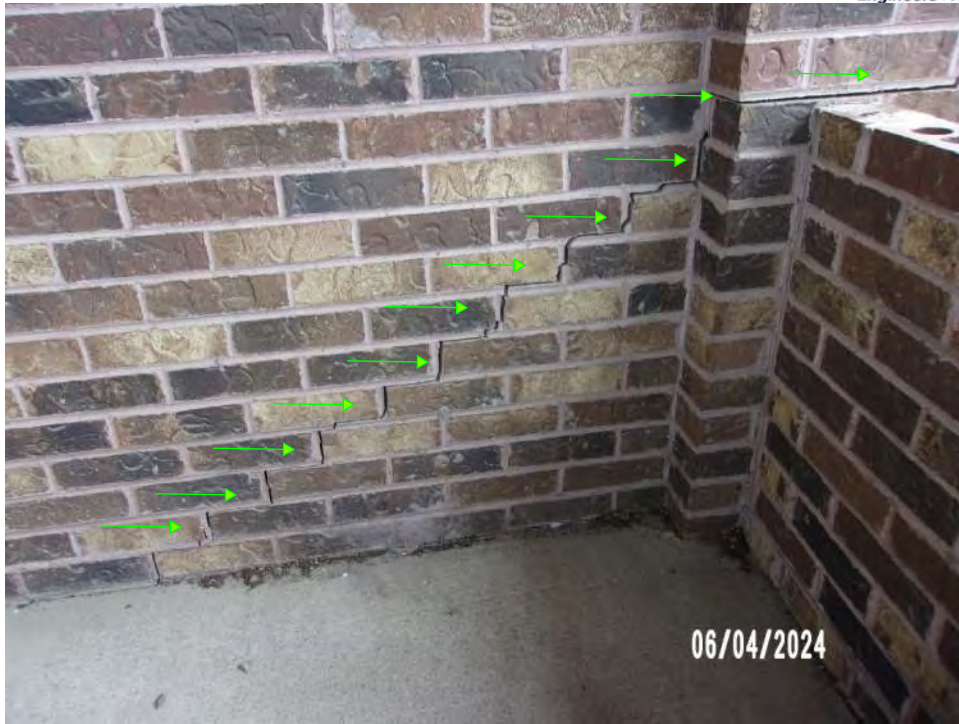
Photo 9 – Crack in south brick wall

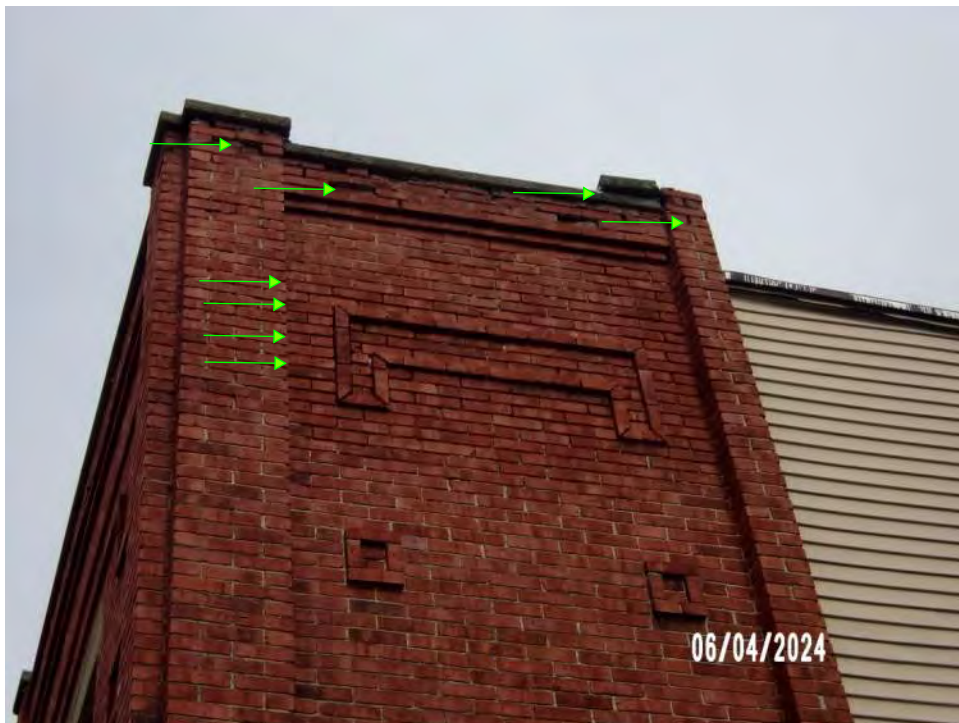
Photo 10 – Poor mortar joints in brick on east and south face of building

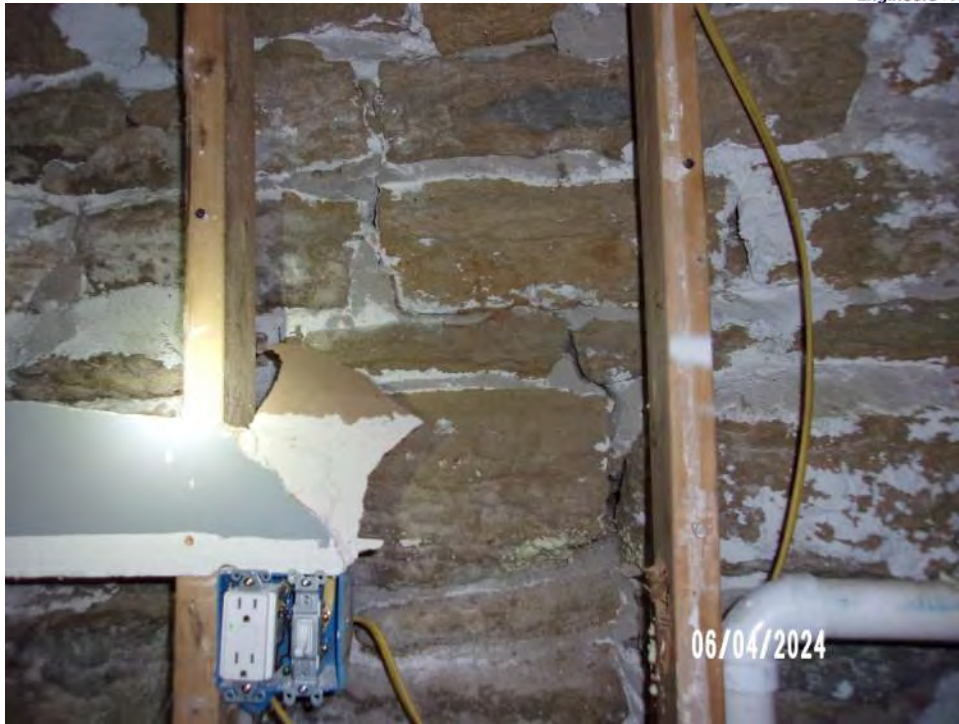
Photo 13 – Crack in south stone foundation wall

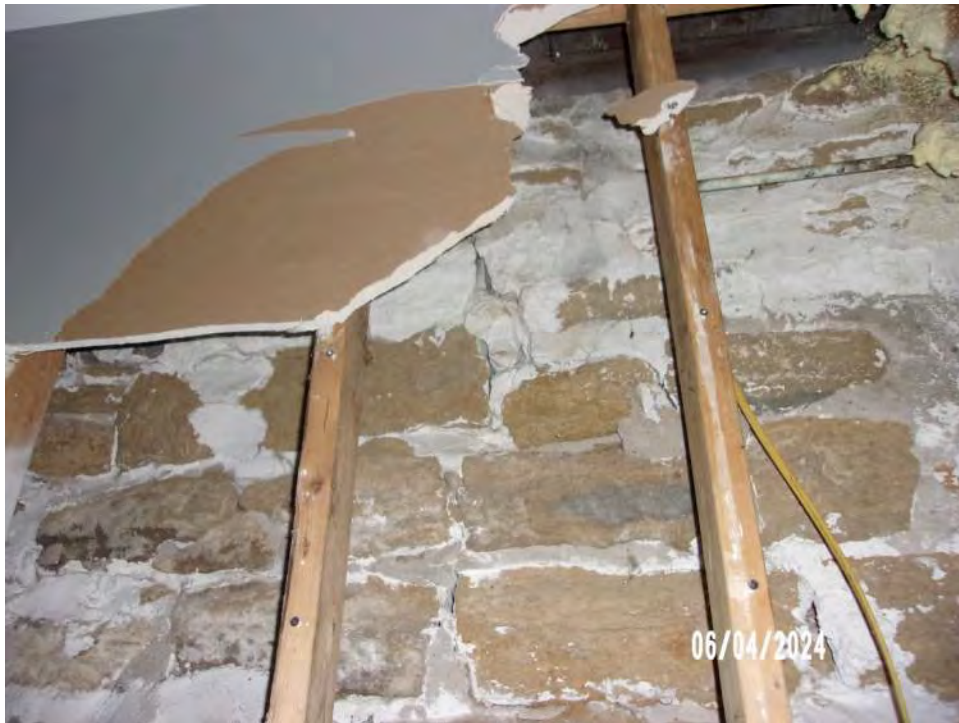
Photo 14 – Crack in south stone foundation wall

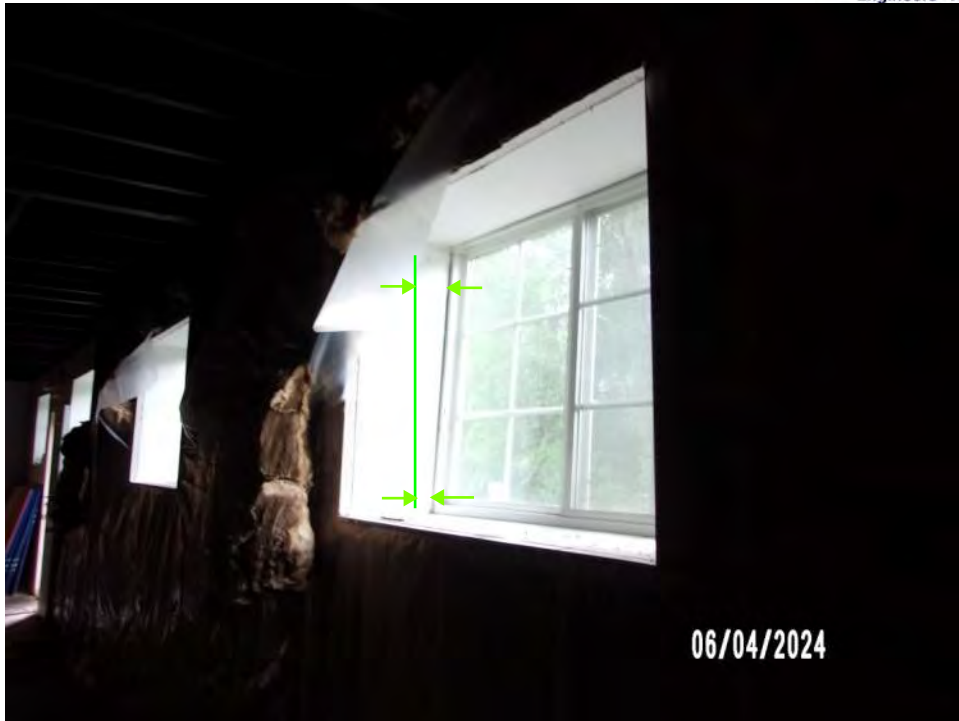
Photo 15 – Windows set in wood wall lean to the east

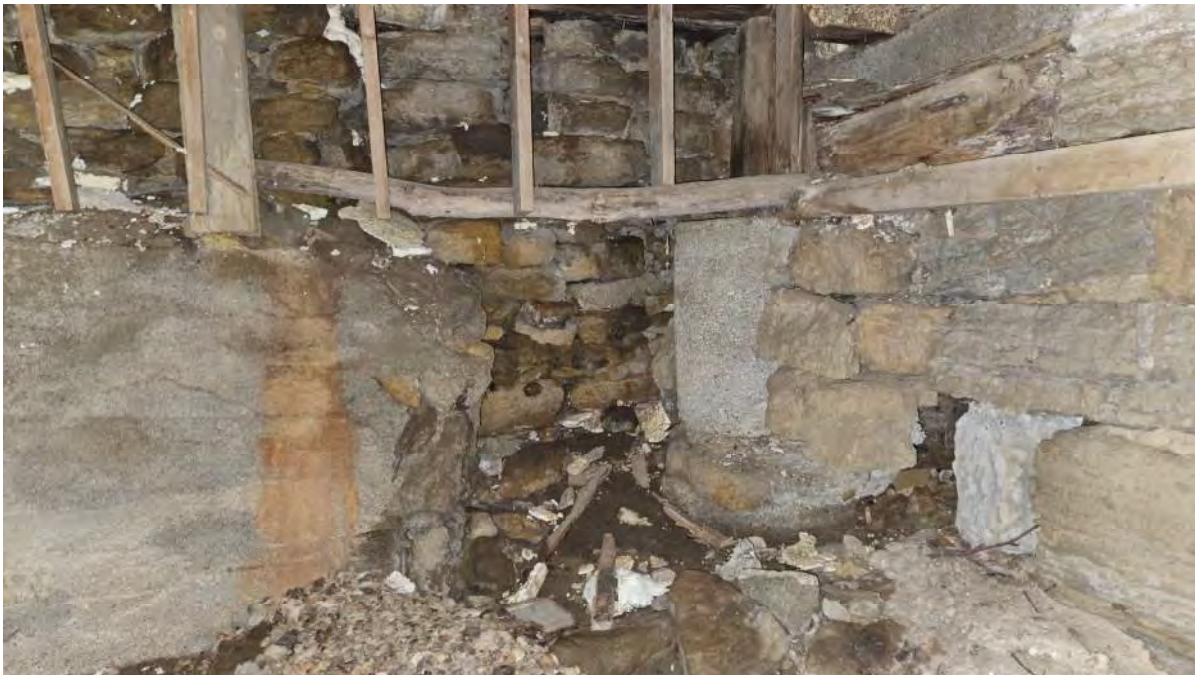
Photo of SE corner of lower basement showing crumbling stone foundation, timber floor support system and concrete concrete wall poured against stone foundation.

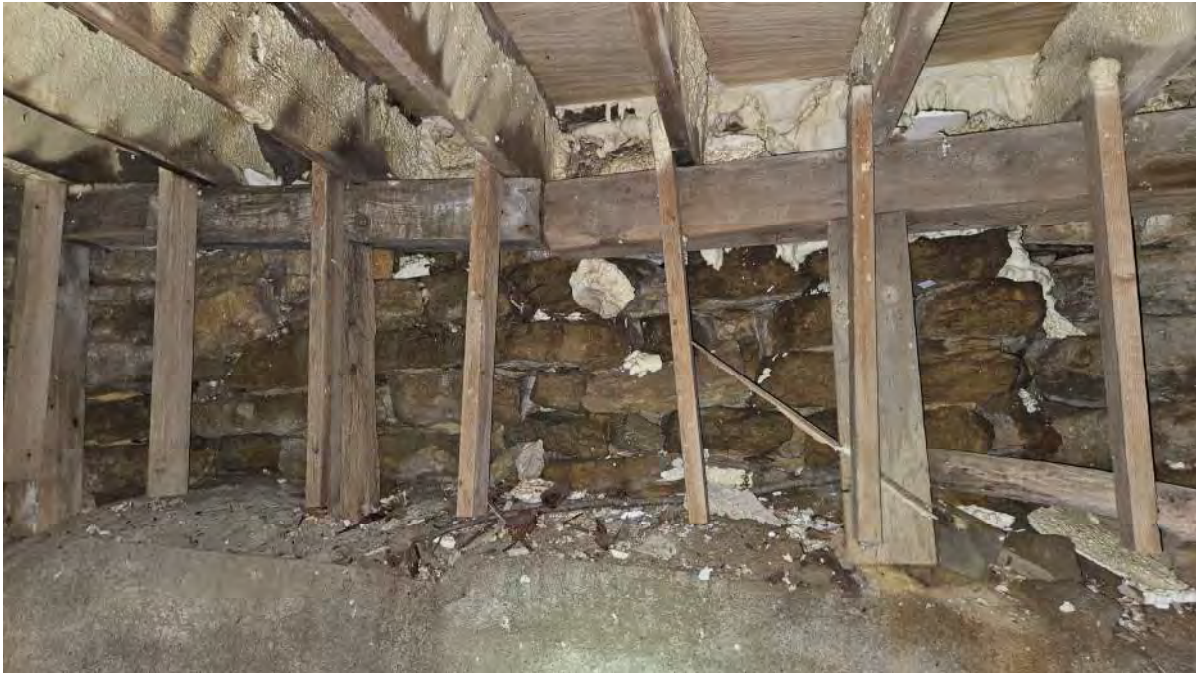
Photo showing timber floor support system

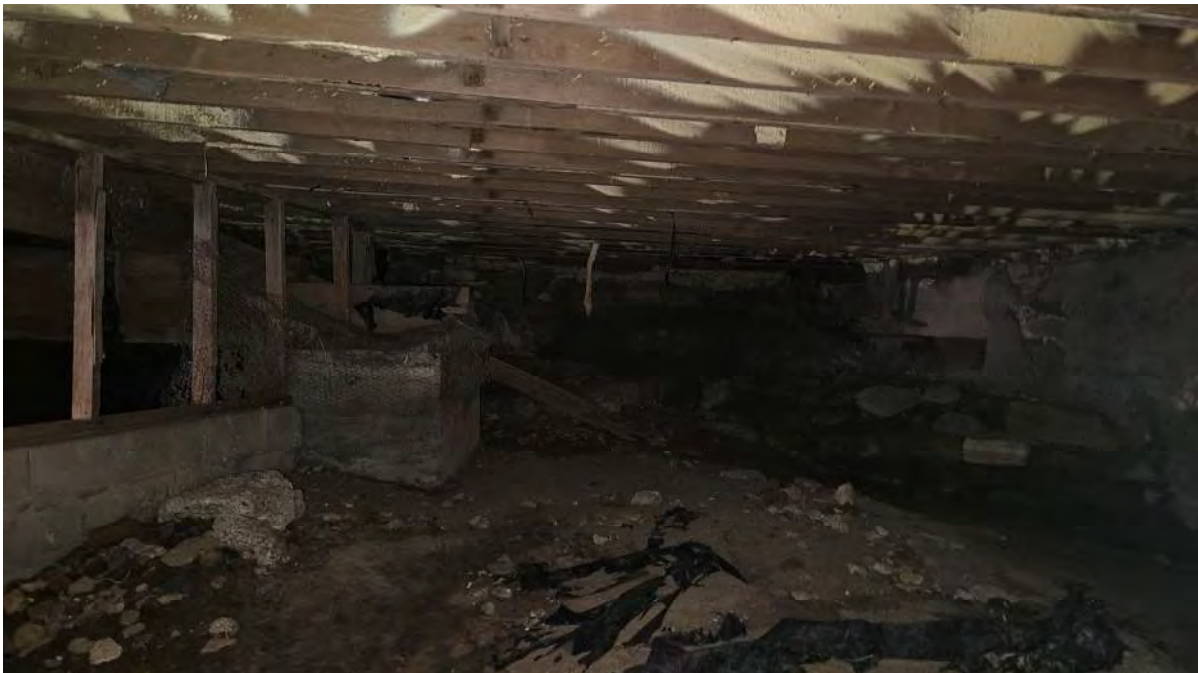
Photo looking south at the southwest corner of the foundation

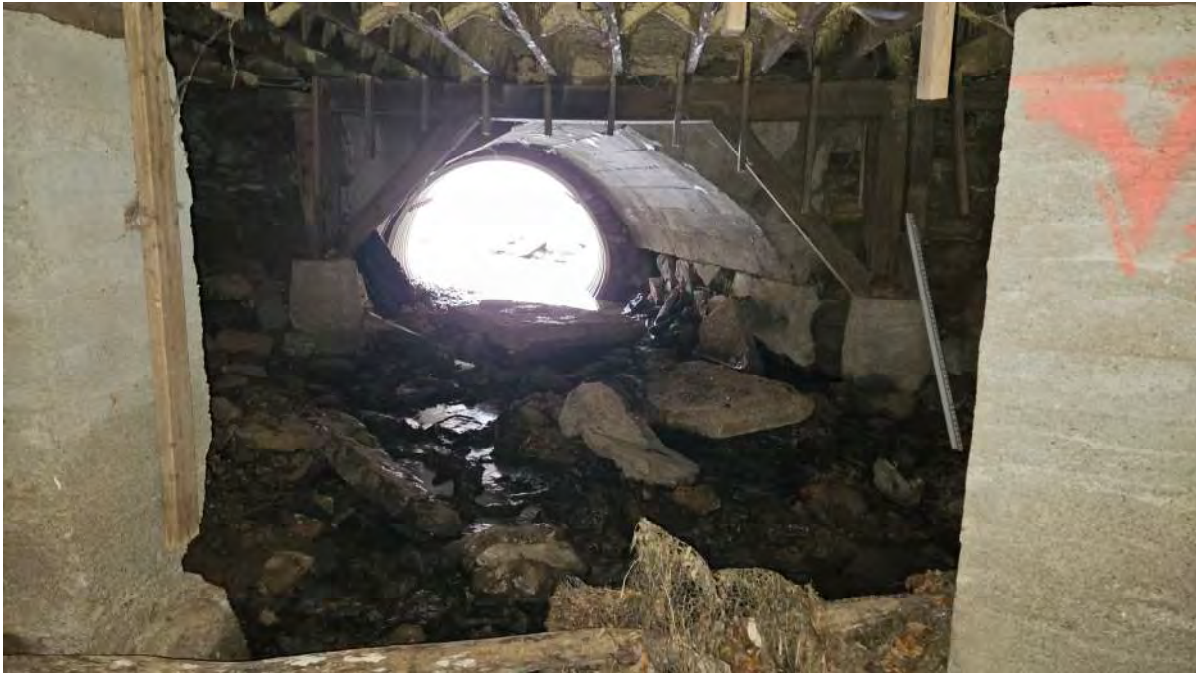
Photo of the entry culvert
